GAS COUNTERS AGING FOR DUMMIES

Fabio Sauli* European Organization for Nuclear Research (CERN) 1211 Geneva 23, Switzerland

Invited presentation at the 3rd International Conference on Detector Stability and Aging Phenomena in Gasous Detectors, this work summarizes the major outcomes of research on the processes of performance degradation of gaseous detectors on exposure to ionizing radiation, since the first observations with Multi-Wire Proportional Chambers in the early seventies of last century.

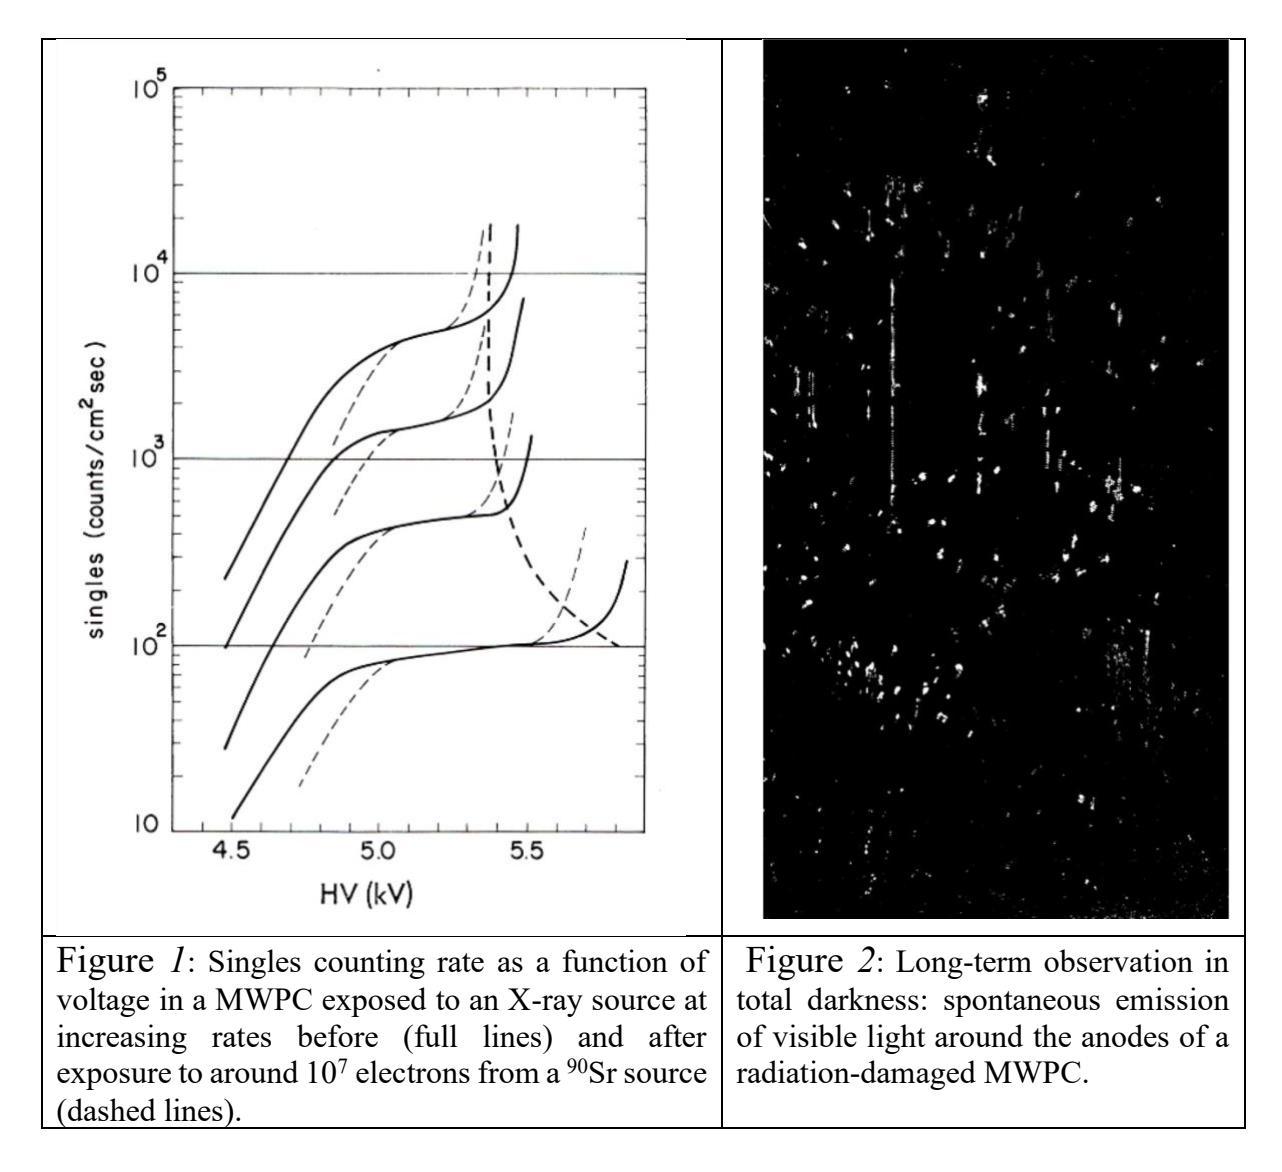
Operating a damaged device at high gains permitted to observe the emission of visible photons around the regions affected by the degradation process, as shown in Figure 2, revealing the presence of localized or extended discharge clusters; bizarrely, the luminous emission clusters seemed to move

around in sudden jumps, probably due to electrostatic repulsion. The cause of the emissions was identified to be the presence on the anode wires of dust particles and/or deposits of various nature, residuals of the manufacturing process or resulting from the creation under discharge conditions of solid or liquid polymers of the filling gas, generally using large fractions of hydrocarbons as quenchers.

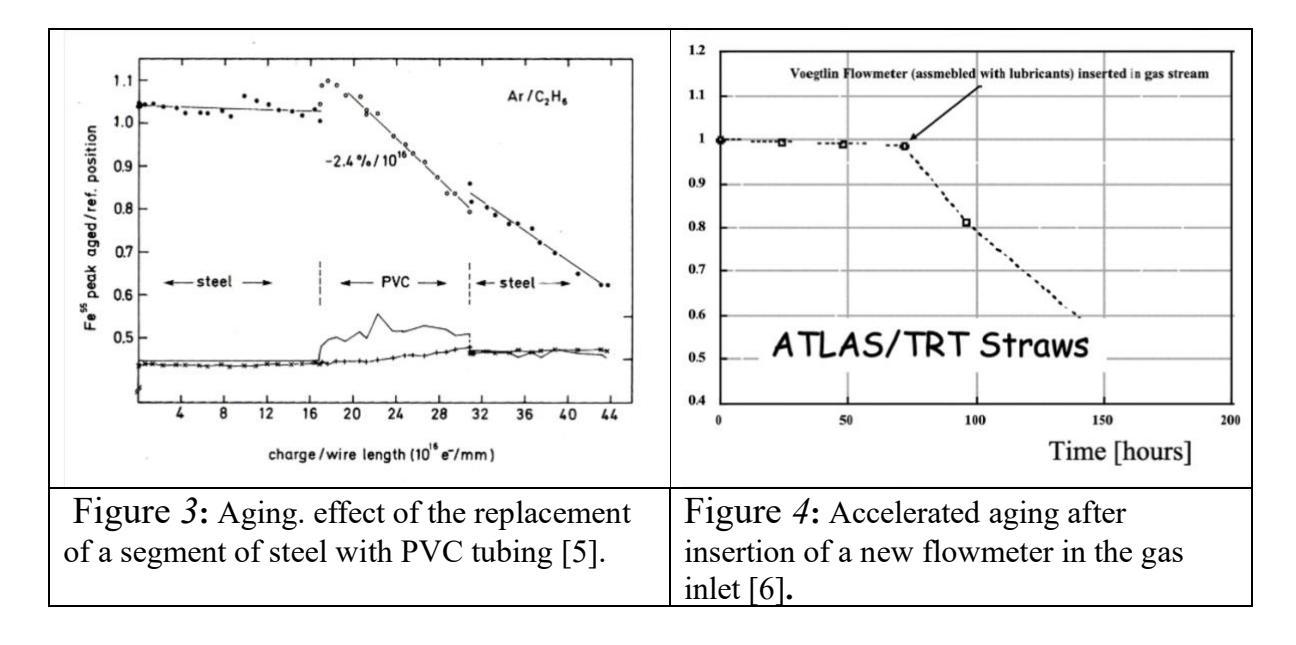
In the early studies it was observed already that small changes in the gas input lines could largely enhance the degradation, or aging rate, of a wire detector, as seen in the examples of Figure 3 and Figure 4. In the first case a short portion of the original stainless steel tubing was replaced with a plastic PVC segment; in the second case, a mechanical flowmeter was inserted in the gas input line. Once initiated, the degradation persists albeit at a lower rate, indicating the presence of a permanent damage to the anodes. In the two examples, the culprits were recognized to be the release of volatile plasticizer composites in the PVC, and residuals of the lubricants used for manufacturing and operating the flowmeter.

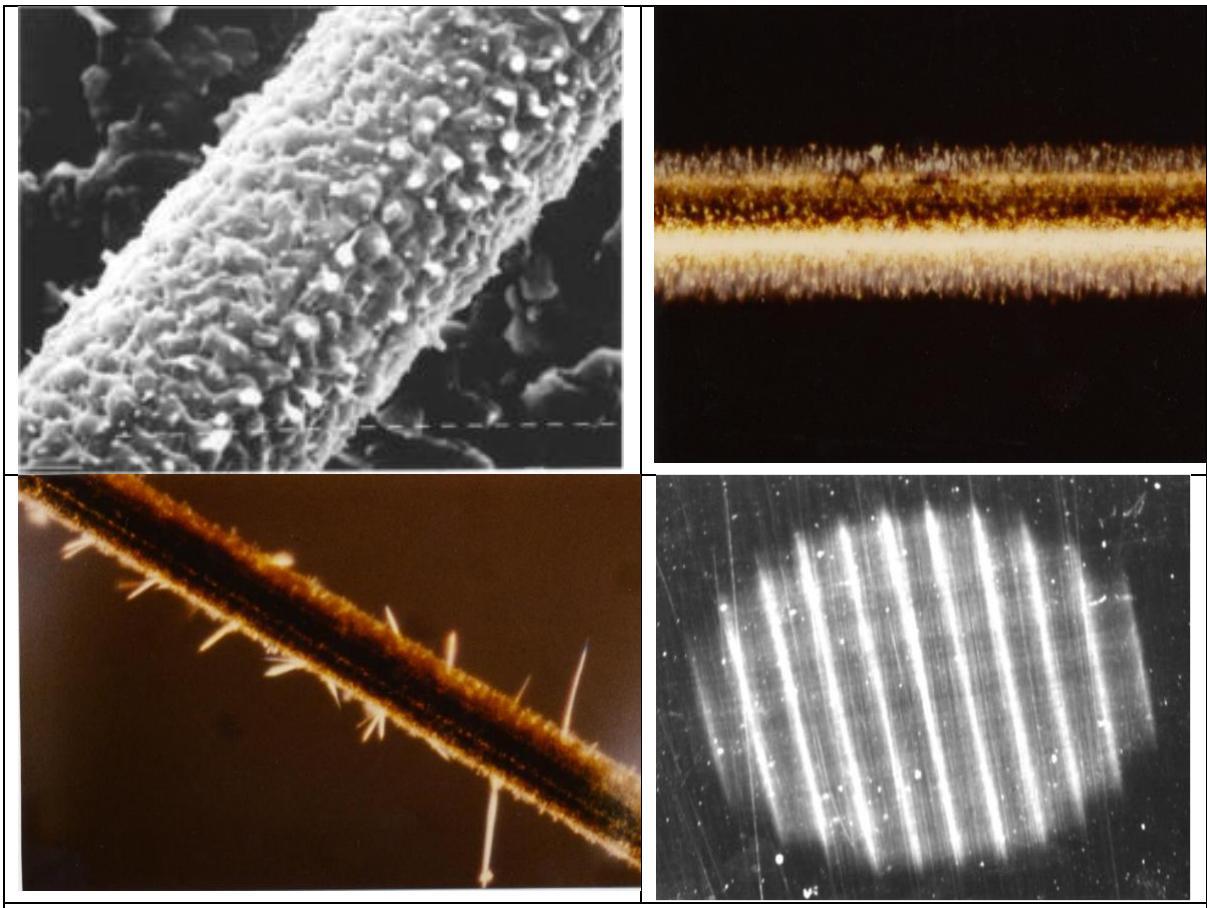
Figure 5: Examples of deposits on electrodes observed in aged wire chamber; the bottom right image is the patterned damage seen on a cathode plane facing the irradiated area. Figure 5

Optical inspection of radiation-damaged detectors reveals the presence on the damaged anodes of heavy deposits, flakes and spikes, and discolorations on cathodes, see Figure 5. Anodic deposits are recognized to be carbon-based polymers of the filling gas, while cathode patterns seem the result of oxidation or reactive ions bombardment. For an extended discussion on the nature of the residues and their effect on the detector operation see the proceedings of the first Workshop on Radiation Damage to Wire Chambers held in Berkeley in 1986 [7] and review papers on the subject [8][9][10].

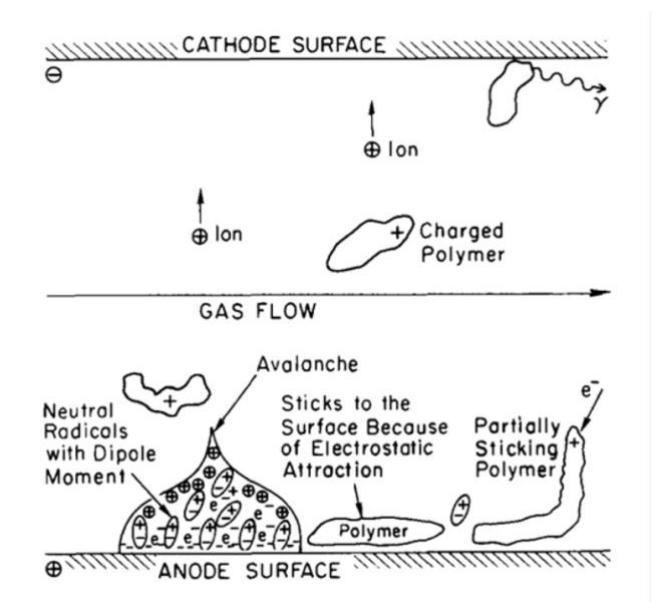
Figure 6: Schematics of the formation of polymers of organic molecules under avalanche conditions [11].

The residues commonly found on anode wires have been identified as the results of polymerization of the organic gases, used as quenchers to achieve stable operation: methane, ethane, isobutane and other hydrocarbons. Subject to collisions with energetic electrons in the avalanches, the molecules dissociate forming radicals, that recombine forming precursors that can attach to form long chains of compounds, as shown schematically in Figure 6 [11]. The processes are described by the field of plasma chemistry¹.

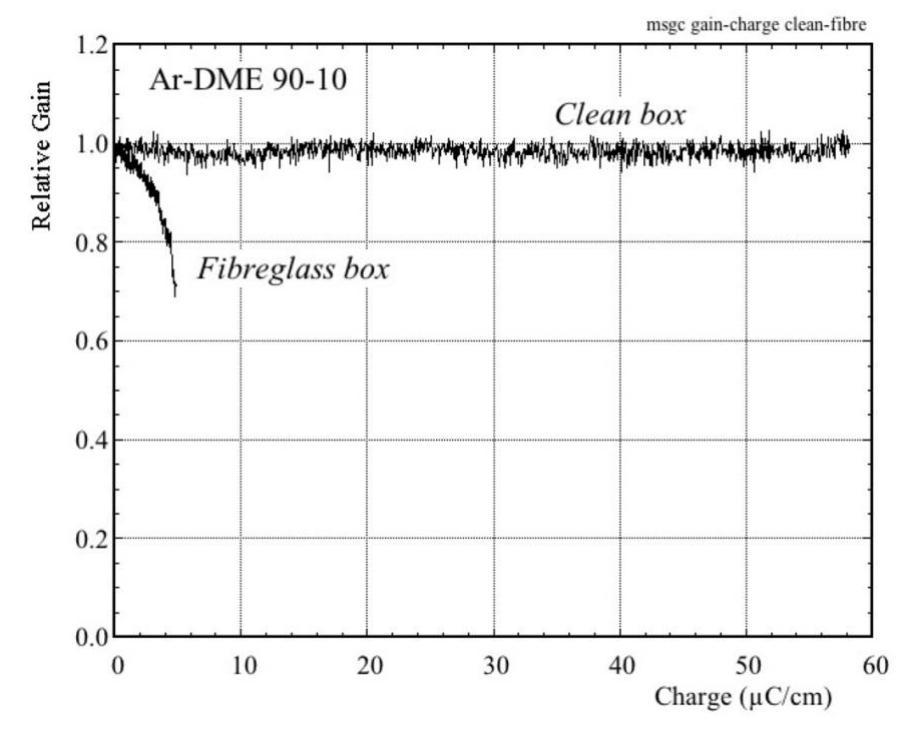
Figure 7: Relative gain dependence from collected charge measured exposing to ionizing radiation an MSGC assembled within a fiberglass-epoxy container and in a "clean" stainless stees and aluminum box [15].

The introduction in 1988 of the Micro-Strip Gas Chamber (MSGC) [14], extending the rate capability of wire-based detectors, generated new concerns about long-term survivability, as they appeared more prone to age in presence of even very small amounts of pollutants. Figure 7 shows an example of relative gain measured as a function of collected charge with an MSGC plate exposed to a soft X-ray flux and mounted either in a standard fiberglass-based frame or in a "clean" box made of stainless steel, aluminum and glass [15]; the difference in behavior is spectacular, indicating the extreme sensitivity of the detector to even minute amount of impurities.

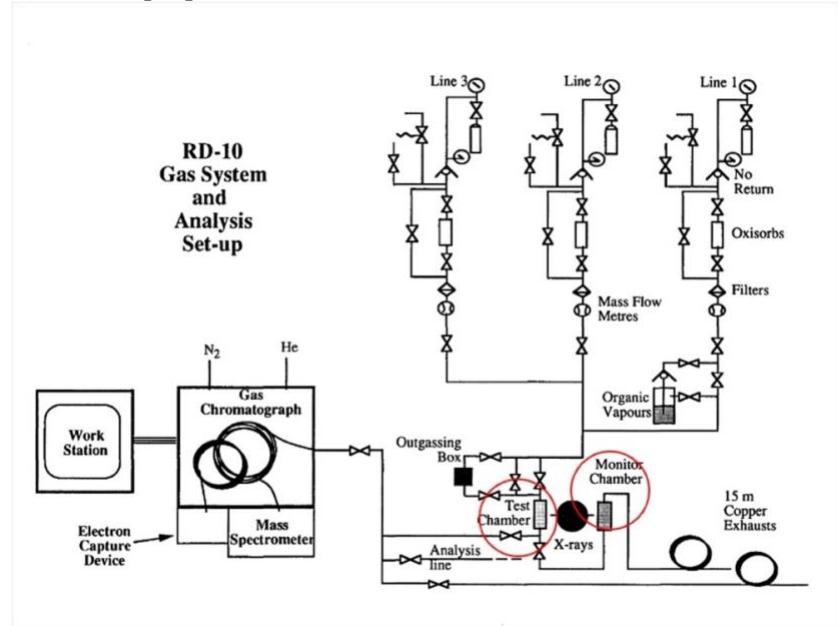
Figure 8:The RD-10 setup with the chamber under test irradiated with a high X-ray radiation flux.. The volatile yields carried with the gas flow are analyzed with a gas chromatograph.

environments. Figure 8 shows schematically the setup used to study aging properties of detectors exposed to a continuous flux of ionizing radiation. A measurement of detector current as a function of time permits to record the radiation exposure, wile a monitor chamber exposed to an attenuated flux is used to correct variations in gas flow, temperature and pressure. To detect changes in performance, the proportional gain and resolution of the detector under test are recorded at regular intervals under an attenuated flux both inside and outside the irradiated area. A small but essential detail in the setup is the way the gas flow is vented, using a long exhaust pipe instead of the conventional oil bubbler, that was found to contribute to the silicone pollution despite being on the output line.

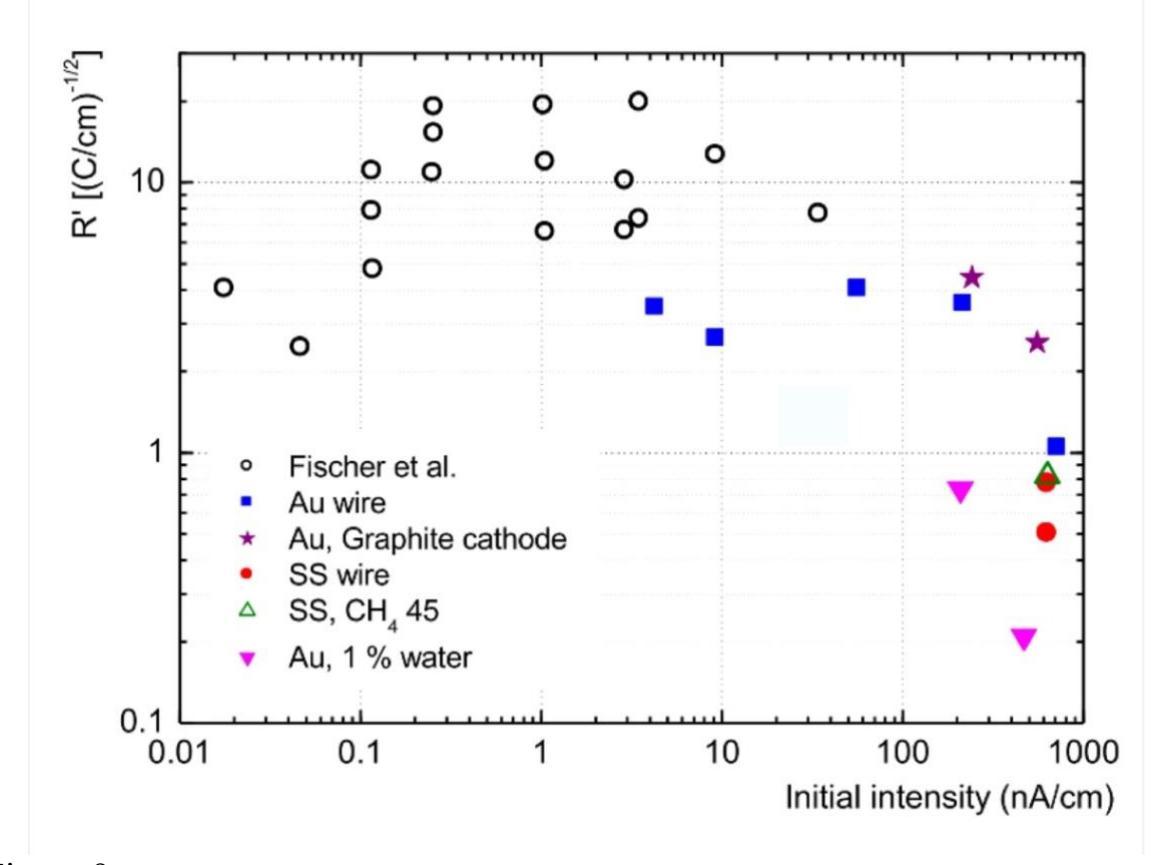
Figure 9: Compilation of aging rate measurements in different wire counters as a function of irradiation current density [19].

The natural unit to express the survivability of gaseous counters is the amount of collected charge per unit surface; for MWPCs, where the distance between wires modulates the charge collection, it is customary to express the charge per length of wire. Other units are used in the literature, making often difficult to compare results: time of exposure, count per unit surface, years of operation. It should be noted that aging tests are necessarily accelerated, often by a large factor, raising doubts about the pertinency of the results in normal operating conditions: it is indeed a know outcome of plasma chemistry that the polymerization rate depends on charge density, roughly increasing with the square root of the dose. The effect is illustrated in Figure 9, a collection of aging rate measurements in counters with Ar-CH₄ fillings, as a function of irradiation charge density [19]. Although compiled for different counters and conditions, the result is indicative of the general trend of high-current measurements to be optimistic, often by a large factor.

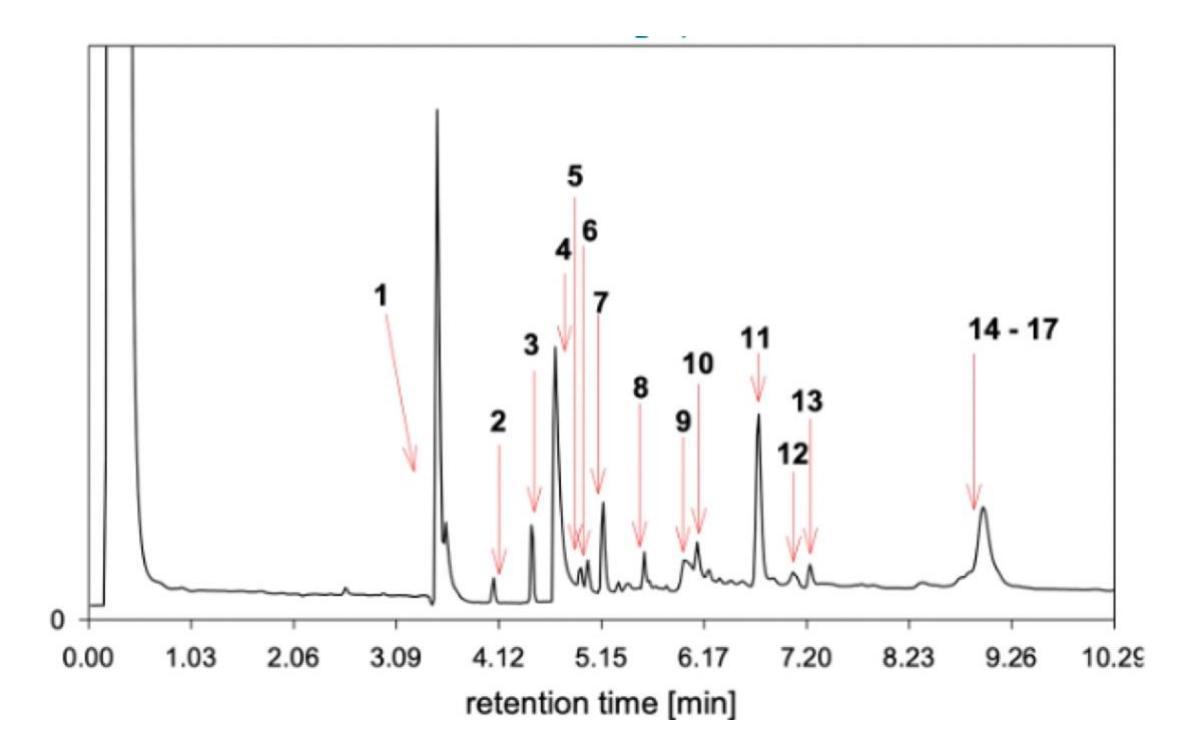
Figure 10: Gas chromatograph spectrum of stable organic compounds created by electron avalanches in an argon-methane. Close to half of the species are able to polymerize. For the identification of the peaks see Ref [20].

A parallel line of research has been conducted by a group at Helsinki University, operating a laboratory setup similar to the CERN system; an example of gas chromatograph analysis of stable organic compounds created by electron avalanches in a proportional counter operated with argon-methane is shown in Figure 10 [20]; many of the species identified are potentially able to produce stable polymers.

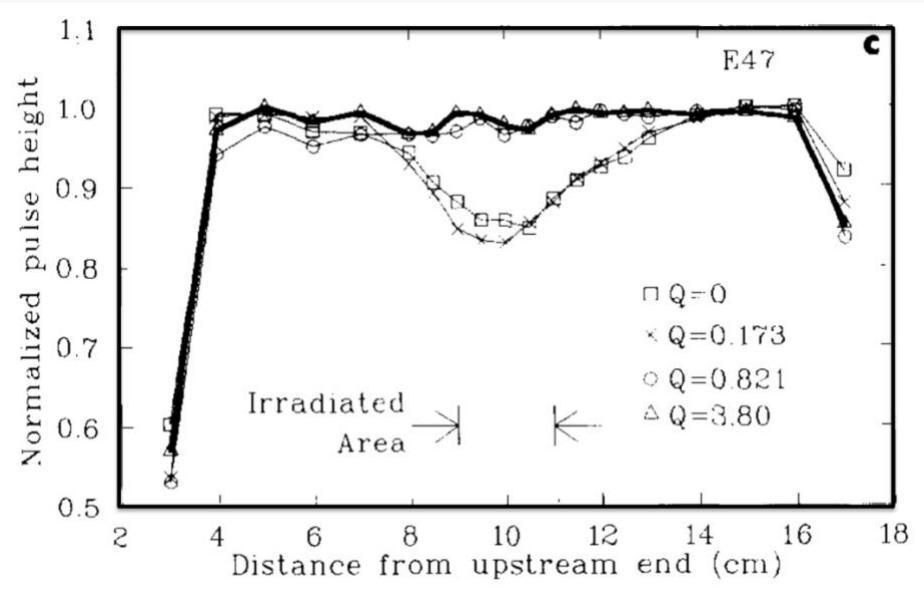
Figure 11: Recovery of an aged section of a MWPC filled with a CF₄-iC₄H₁₀ mixture [21].

Figure 11 is an example of recovery of a section of a MWPC damaged by irradiation in an argon-ethane gas mixture, after replacement of the hydrocarbon with a carbon fluoride-isobutane gas filling [21]. Figure 12 is another example of complete recovery of an aged wire after exposure to a soft X-ray source in a CF₄ mixture [13]; this reference describes also a "training" procedure, consisting in repeated exposures to a radioactive source in the mixture.

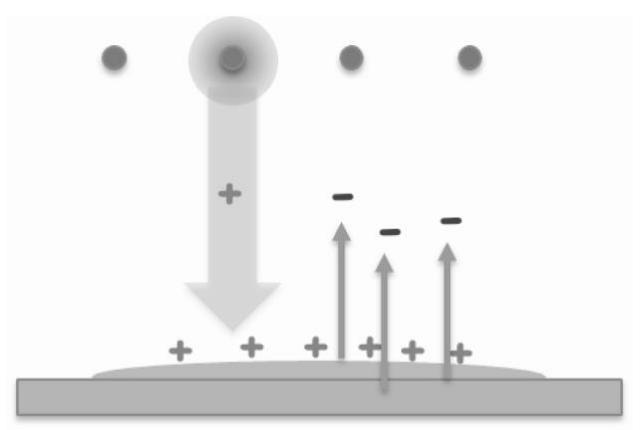
Figure 13: Malter effect: spontaneous secondary electron emission due to the high dipole field created by positive ions accumulating on a thin insulating layer [23].

While polymer and silicone deposits on anode wires result in a local reduction of gain, thin insulating layers deposited on cathodes induce a spontaneous electron emission through the so-called Malter effect, schematically represented in Figure 13. As these secondary electrons return to the anodes and release more ions in the avalanches, the process may become divergent and result in sustained discharges.

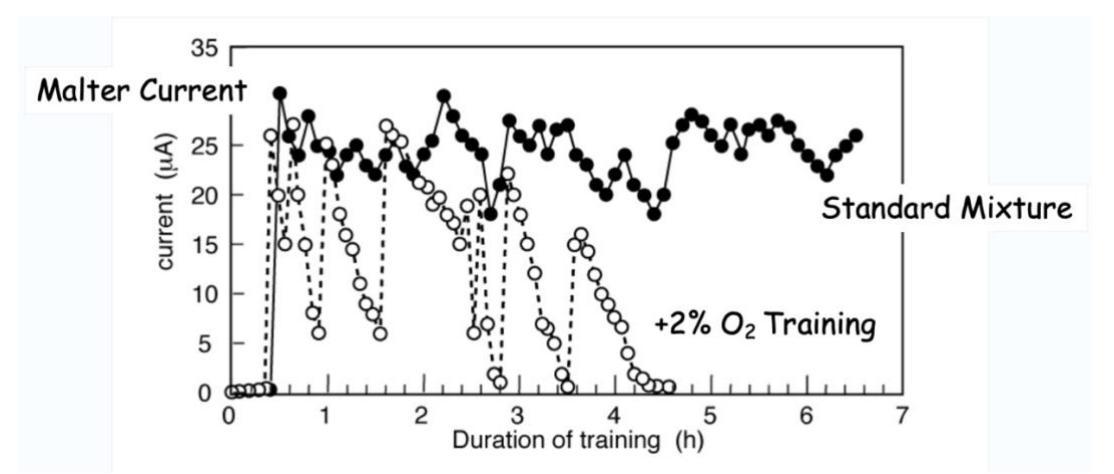
Figure 14: Training process to reduce the Malter current with addition of 2% oxygen in the gas mixture [22].

A training procedure, similar to the one described for anodes, has been used to recover the LHCb muon chambers, and is illustrated in Figure 14: it consists in repeated powering cycles after adding oxygen to the standard operating gas mixture (Ar-CO₂-CF₄) [22].

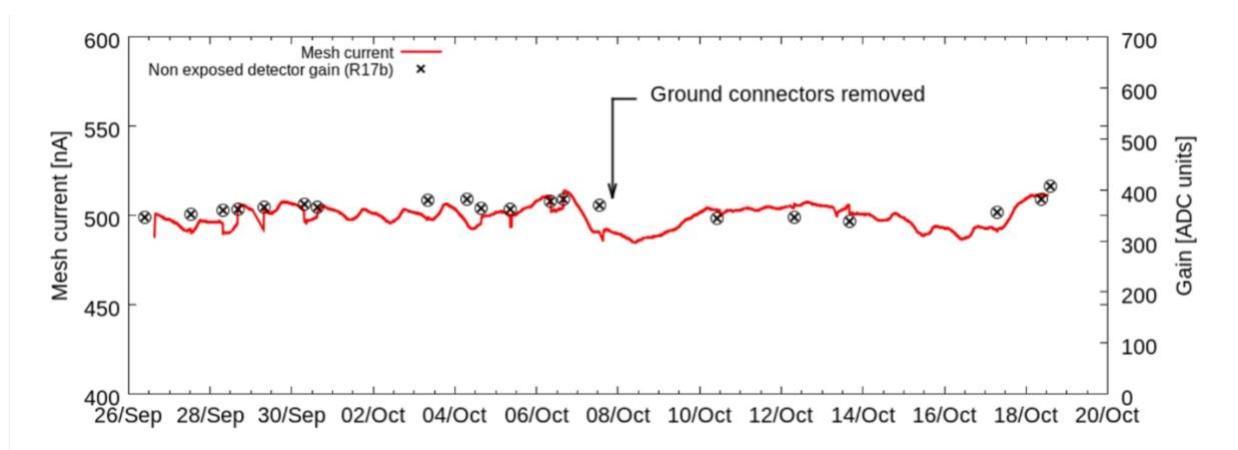
Figure 15: Long-term gain measurement of the ATLAS MICROMEGAS prototype. The total collected charge is ~230 mC/cm² [26].

Adopted for the upgrades of several LHC experimental setups, MICROMEGAS and GEM detectors have been subject of extensive exposures to radiation, with continuous monitoring of their main performances (gain and energy resolution). Figure 15 is the result of a long-term irradiation with an X-ray generator of a MICROMEGAS prototype of the ATLAS muon upgrade; operated with an argon-CO₂ mixture, the detector gain remains unaffected up to a collected charge of 230 mC/cm [26]. Figure 16 is a similar measurement on a Triple-GEM prototype for the CMS forward muon upgrade; the total collected charge on exposure to an X-ray generator is 900 mC/cm², without noticeable changes in gain and resolution [27]. In both cases, the results ensure the survivability of the detectors in the LHC High-Luminosity long-term operation ².

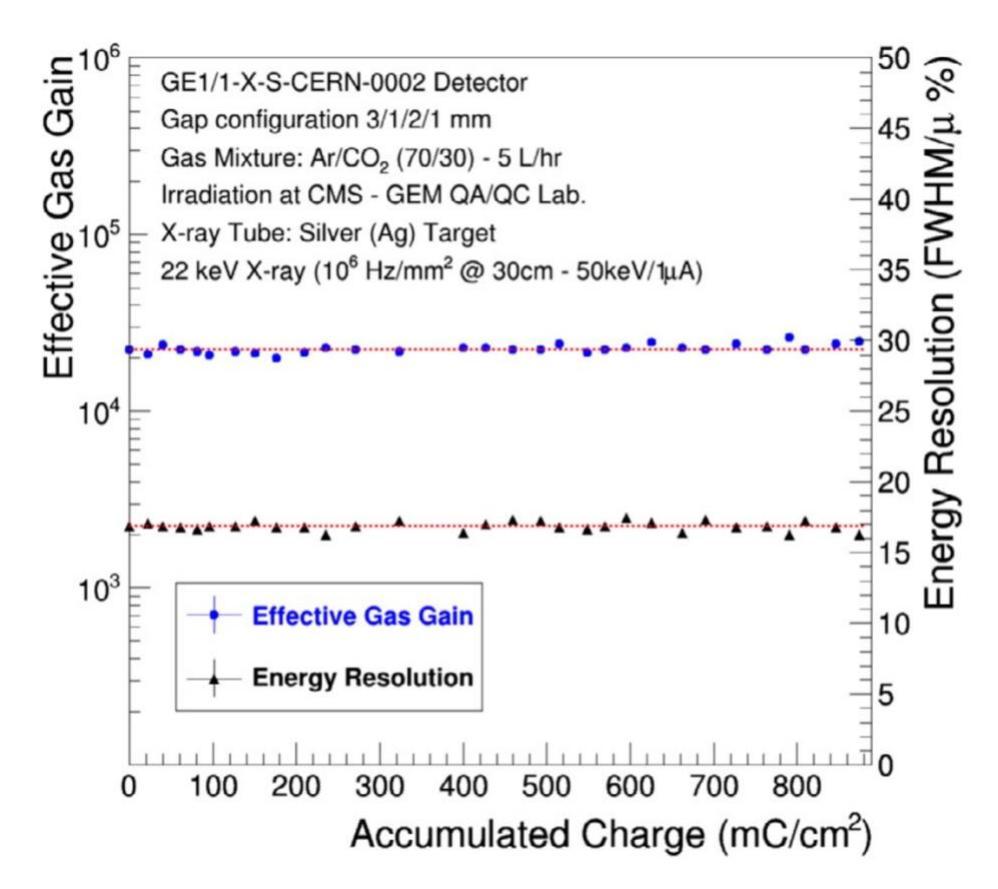
Figure 16: Long-term gain and resolution of the Triple-GEM prototype for the CMS forward muon upgrade [27].

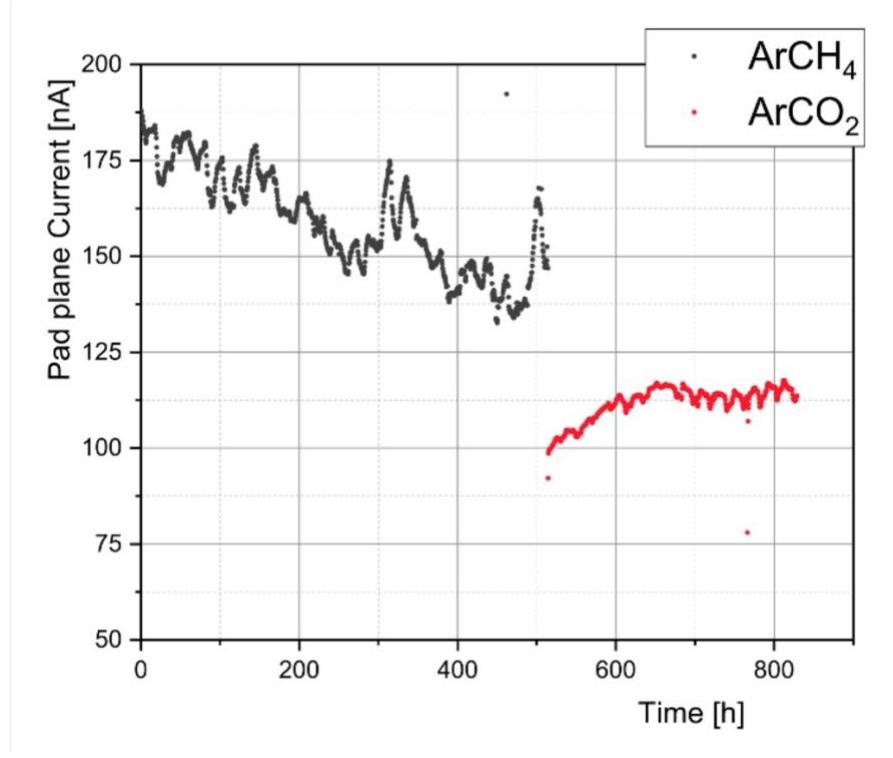
Figure 17: Gain decrease in an ALICE GEM-TPC prototype operated with Ar-CH₄ (left points), and recovery in Ar-CO₂ (right points) [28].

Aging has been observed in MPGDs when the "golden rules" have not been followed. As an example, in a prototype of the ALICE GEM-TPC, a gain reduction by \sim 30% has been observed in Ar-CH₄ after less than 100 mC/cm² of collected charge; the performance recovers and remains constant replacing the organic quencher with CO₂, Figure 17 [28].

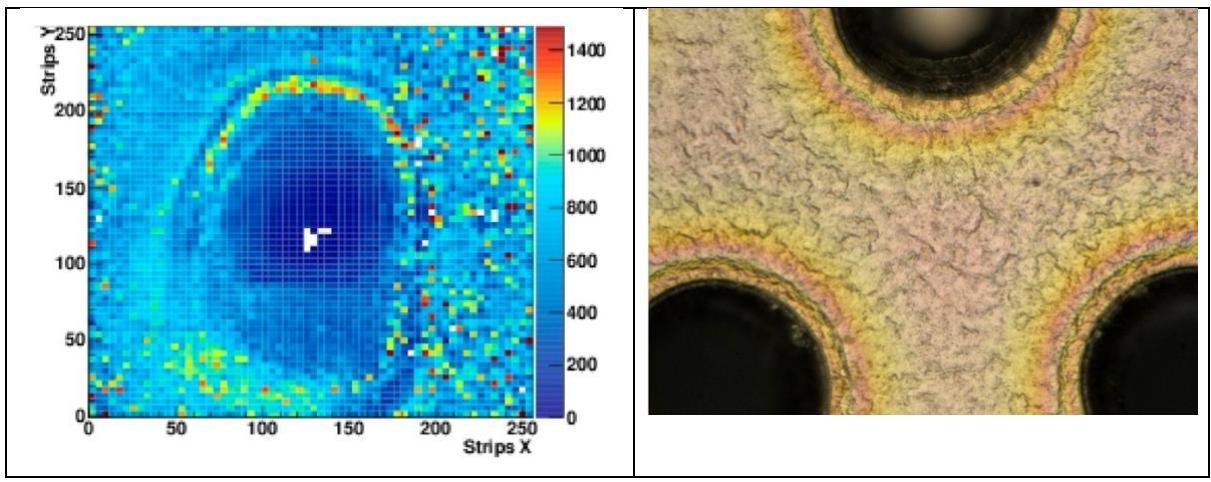
Figure 18: Gain decrease (left) and damages of the electrodes in the irradiated area (left) due to the pollution of a sealant in the COMPASS Pixel GEM detector [29].

An even more manifest result of an unfortunate choice of components has been reported for the COMPASS Pixel Triple-GEM: a deterioration in the area exposed to the beam and the presence of silicone and sulfur deposits on electrodes after an accumulated charge of less than 200 mC/cm², Figure 18. The culprit has been identified to be the use of a sealant (DowCorning 1-2577) to fix a leak.
